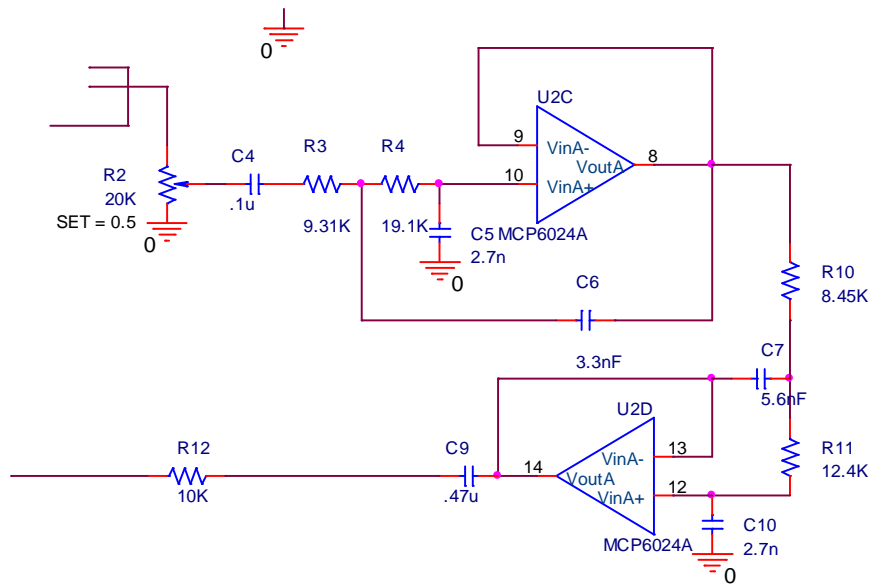
This is the filter section of the design. Input PWM waveform at top left, output to power amp at bottom left.

Suspect that the problem may be in C5 and C10. Both have long traces between themselves and the pins on the opamp, about 1" and 1.5" respectively!
